OPERATION CROSSROADS

BUREAU OF SHIPS INSTRUMENTATION GROUP

Displacements of
Shock Mounted Equipment

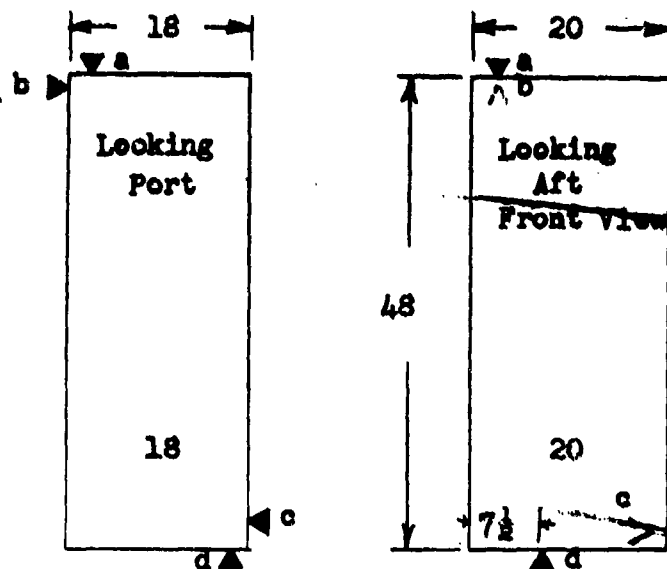
Location: On Radar Transmitter Model SC3 type CG, in Radar Transmitter Room, Second Superstructure Deck. (Near aft bulkhead.)

Type of Mounting: C type mounts on the four bottom corners and on bottom edges between the corners (total eight mounts on bottom). Two C type mounts on the upper back corners. About one inch vertical clearance.

Baker: There was negligible shock and damage. In spite of the negligible shock intensity the displacement of the top of the tall narrow transmitter was 1.3 inches. This indicated the large displacements caused by rocking modes of poorly mounted equipment.

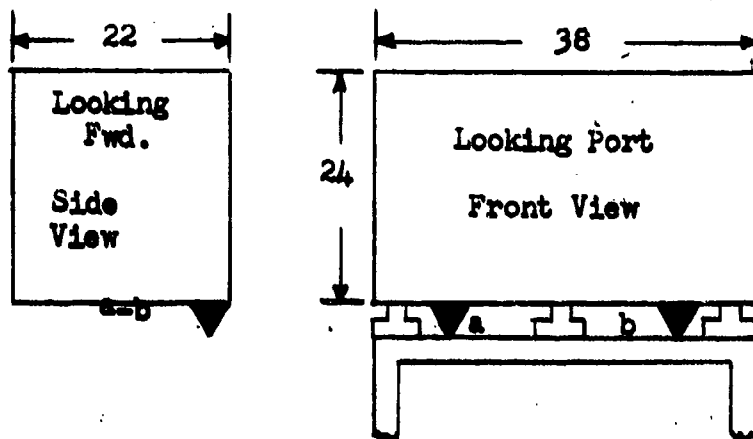
Location: On Range and Train Indicator type CRP-55ABC-3
Room, Second Superstructure Deck (port side).

Type of Mounting: Three C type mounts, as shown, run the full depth of the equipment. Clearance is about 1/2 inch.

Baker: The shock caused by Baker test was very severe. The mounts did not fail although they were not stiff enough to be effective.

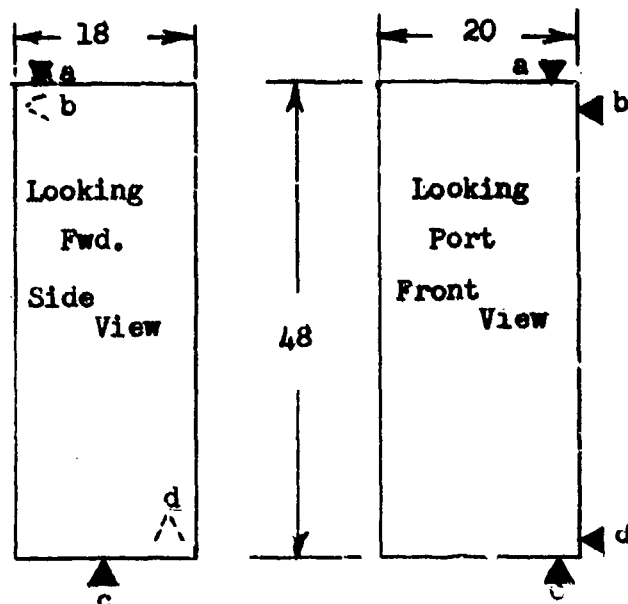
Location: On Radar Transmitter Model SC-2, type CG, in Radar Transmitter Room, Second Superstructure Deck.

Type of Mounting: Short C type mounts on four bottom corners and in middle of front and back bottom edges. C type mounts on upper back corners. Vertical clearance less than 1/8 inch (rubber had crept).

Baker: All of the mounts failed for test Baker, allowing the gear to become loose. The compartment was wrecked.
